Geologists assist in TMI-2 core assessment

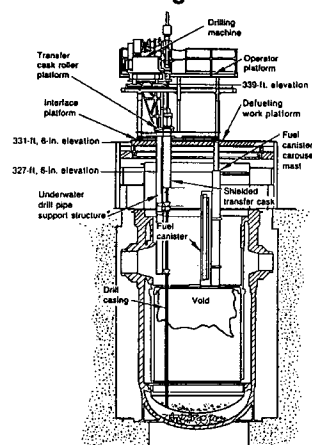
Core Boring Machine

THE CORE BORE system was developed from a commercially available unit built for the mining/geology industry and is installed on the defueling platform erected above the TMI-2 reactor vessel as shown above.
